**After Action Report: October 4, 2017 and October 12, 2017
Site Visits
Table Top Site Investigation
27th Avenue Remediation Site,
Maricopa County, AZ**

December 1, 2017

**Prepared by:
UXO Pro, Inc.
15 Park Avenue
Gaithersburg, MD. 20877**

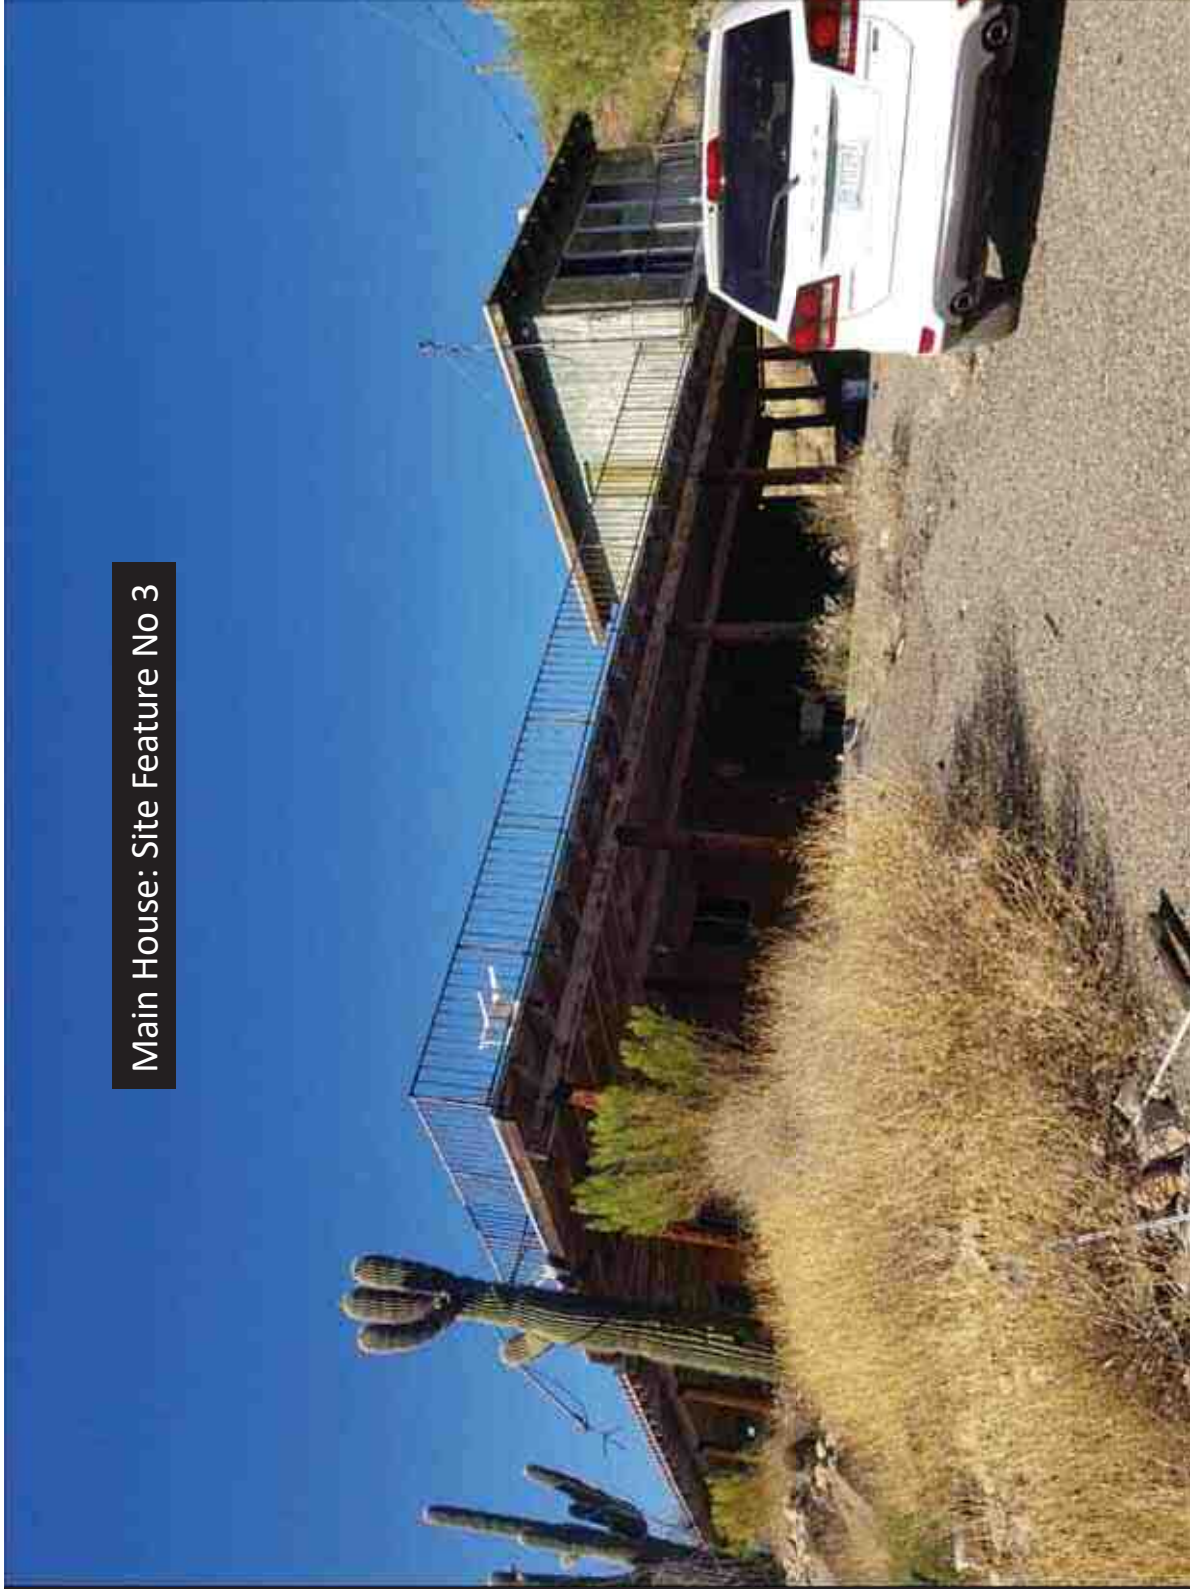
Main House: Site Feature No 3

No MEC, MD or IEDs were identified at this location during the site visit. The main house is under disrepair.

- Recommendations
 - Due to the heavy quantities of cultural debris around these structures, the cultural debris resting on the surface should be removed prior to geophysical investigations.

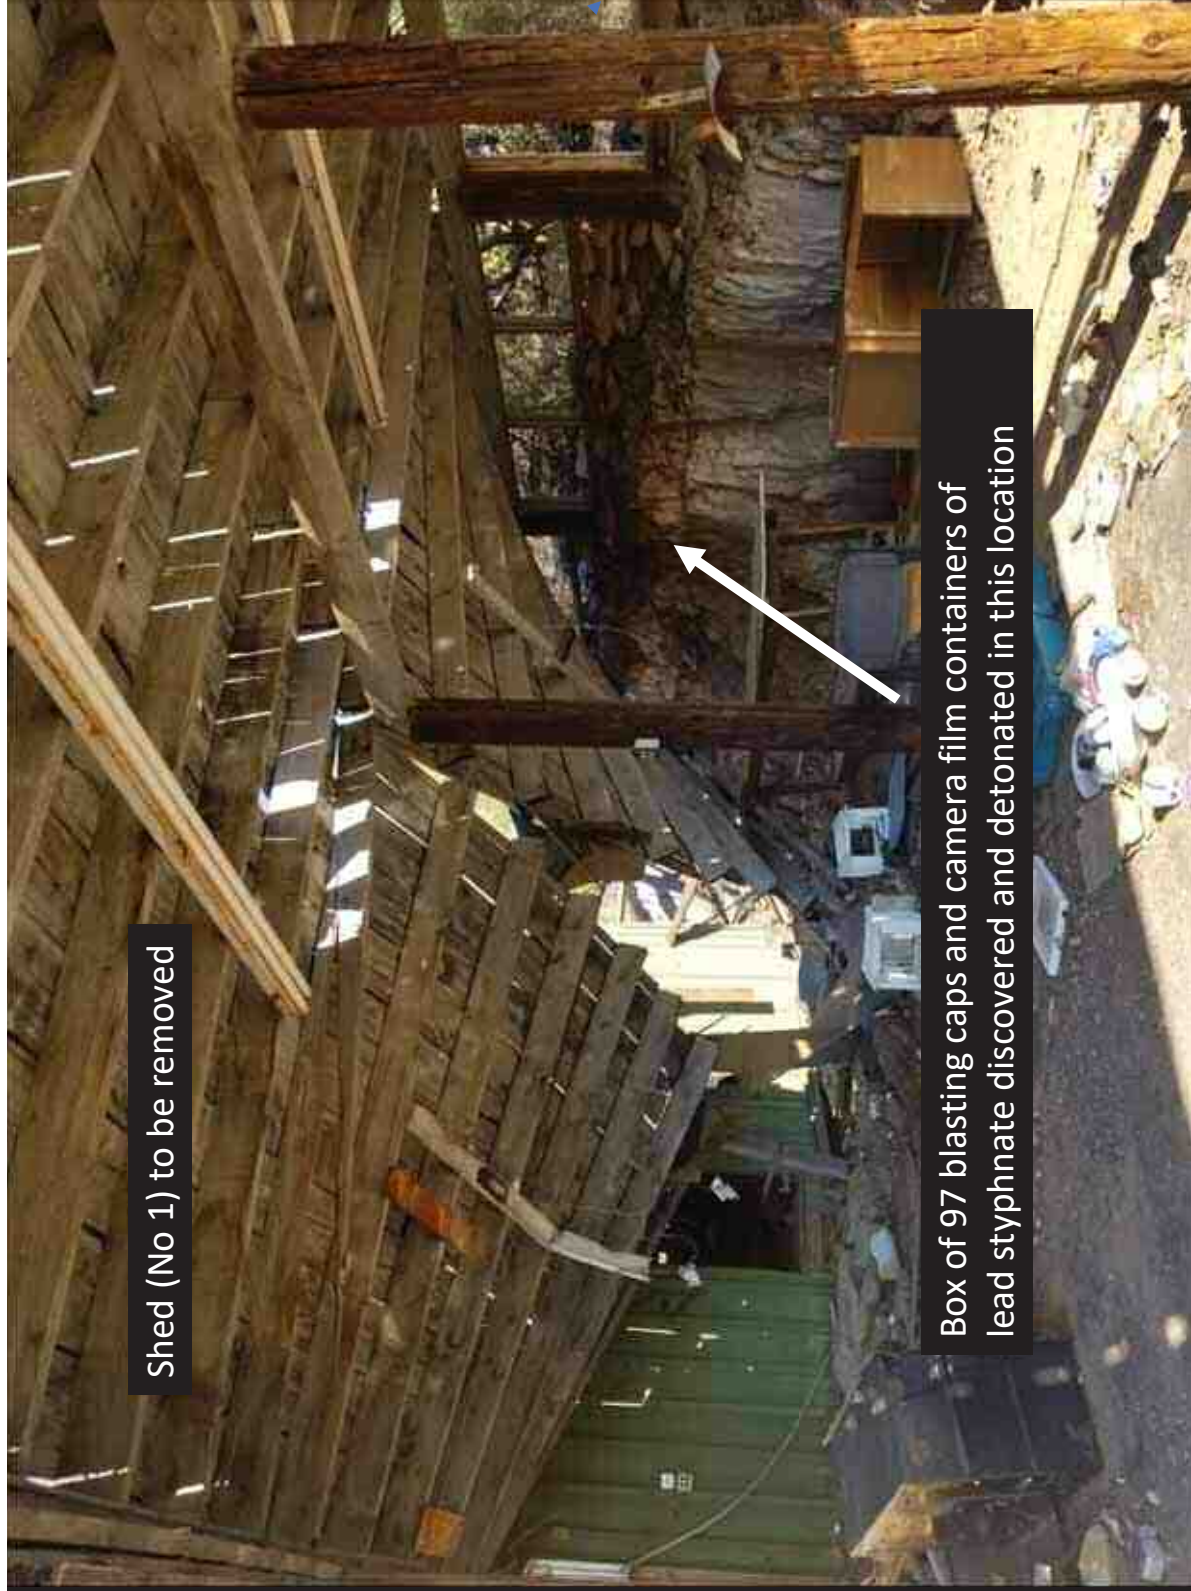
Box of 97 blasting caps and camera film containers of lead styphnate discovered and detonated in this location

Shed (No 1) to be removed

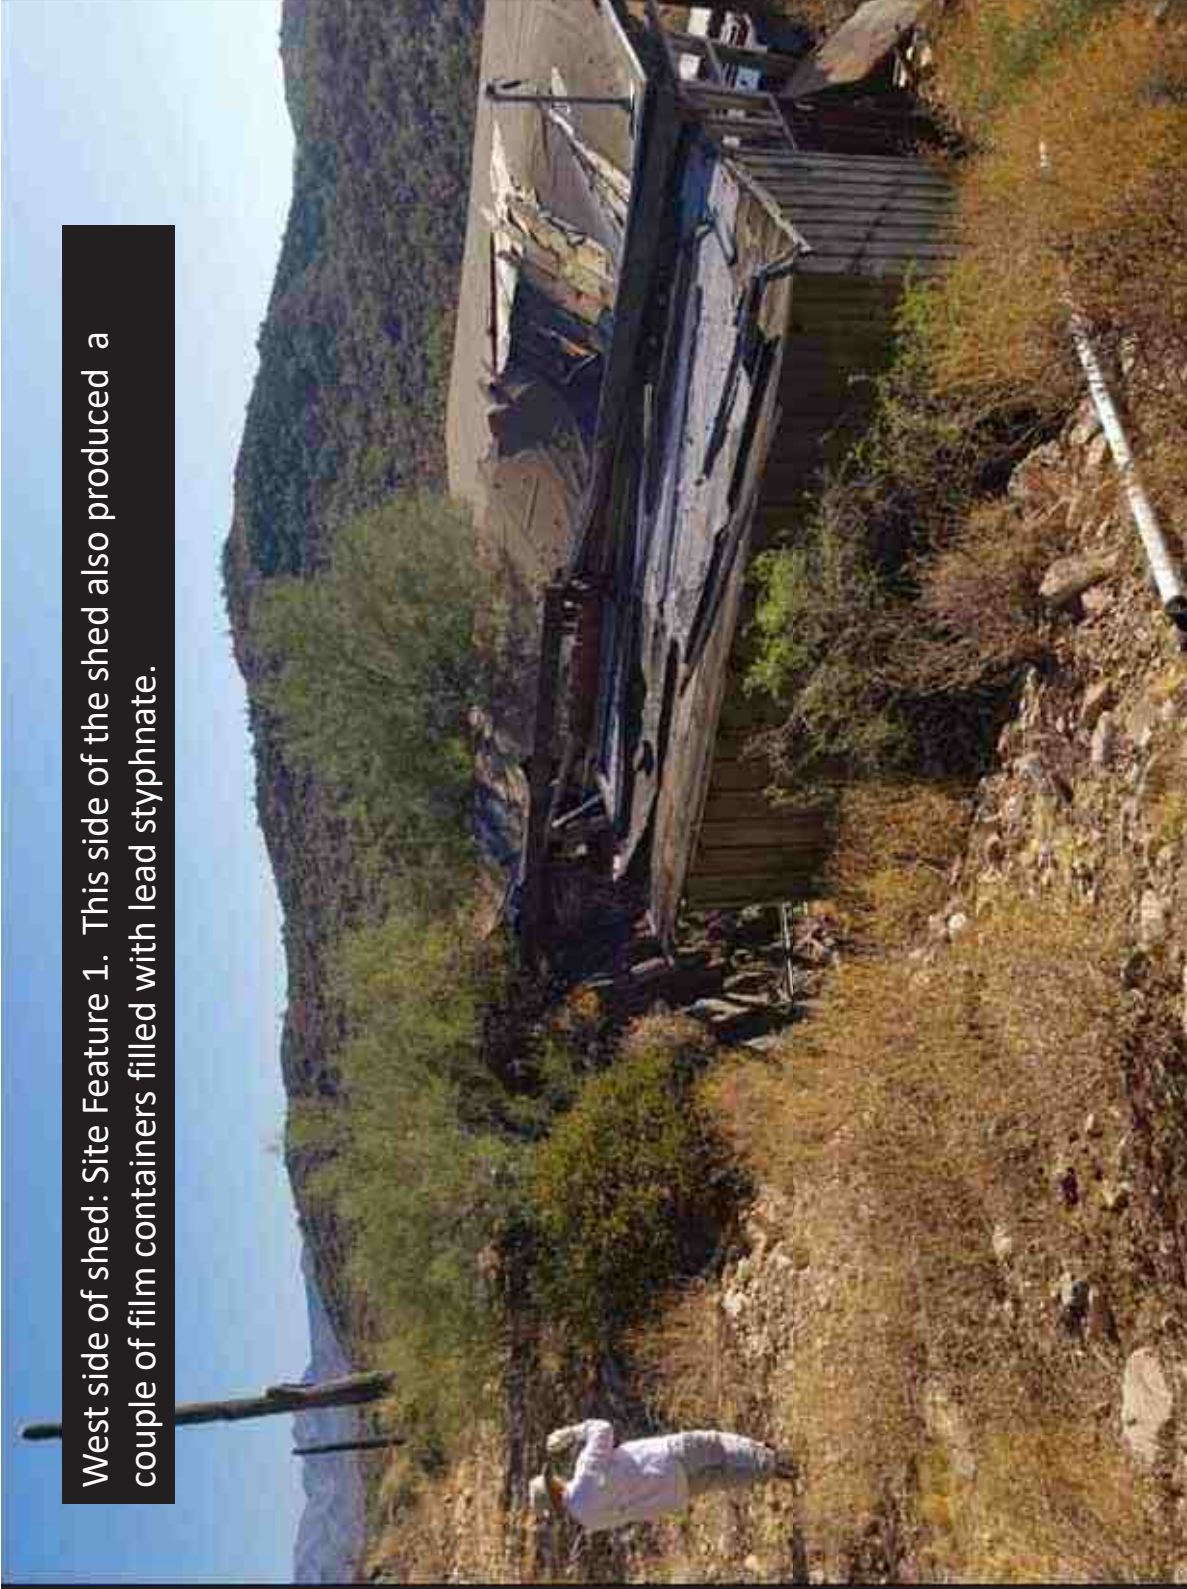
West side of shed: Site Feature 1. This side of the shed also produced a couple of film containers filled with lead styphnate.

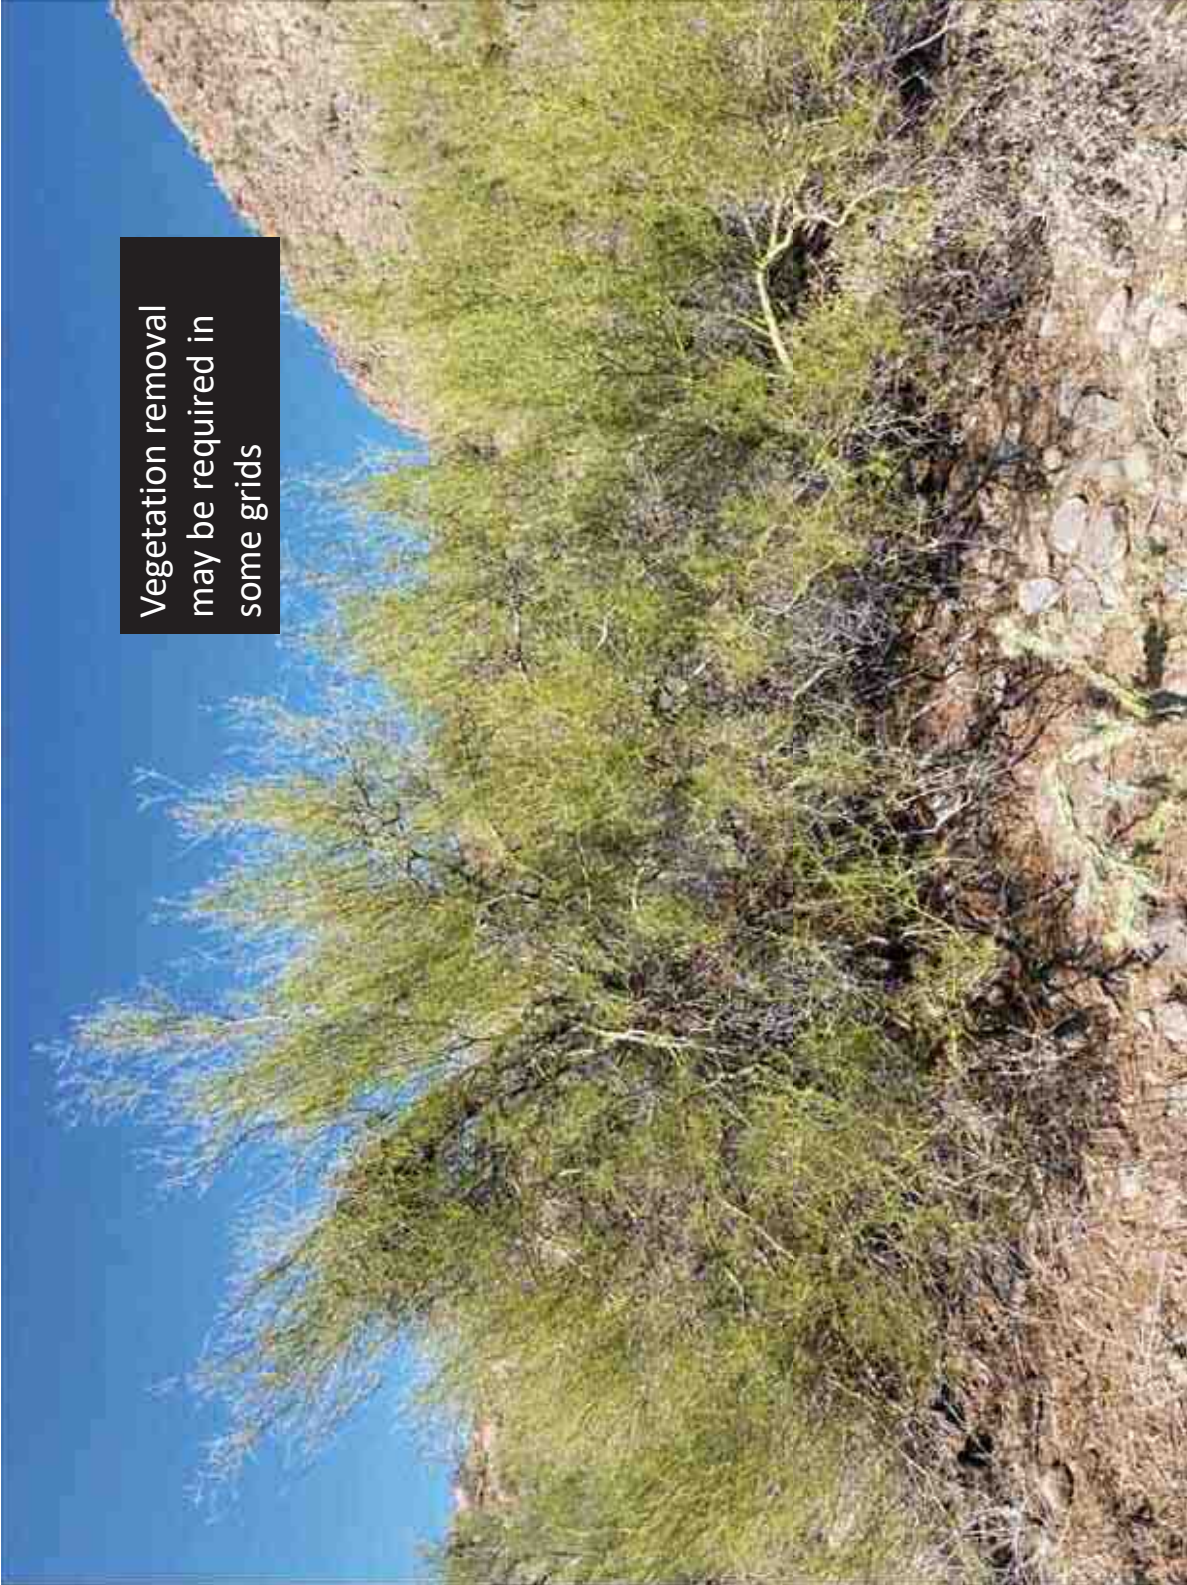
Vegetation removal
may be required in
some grids

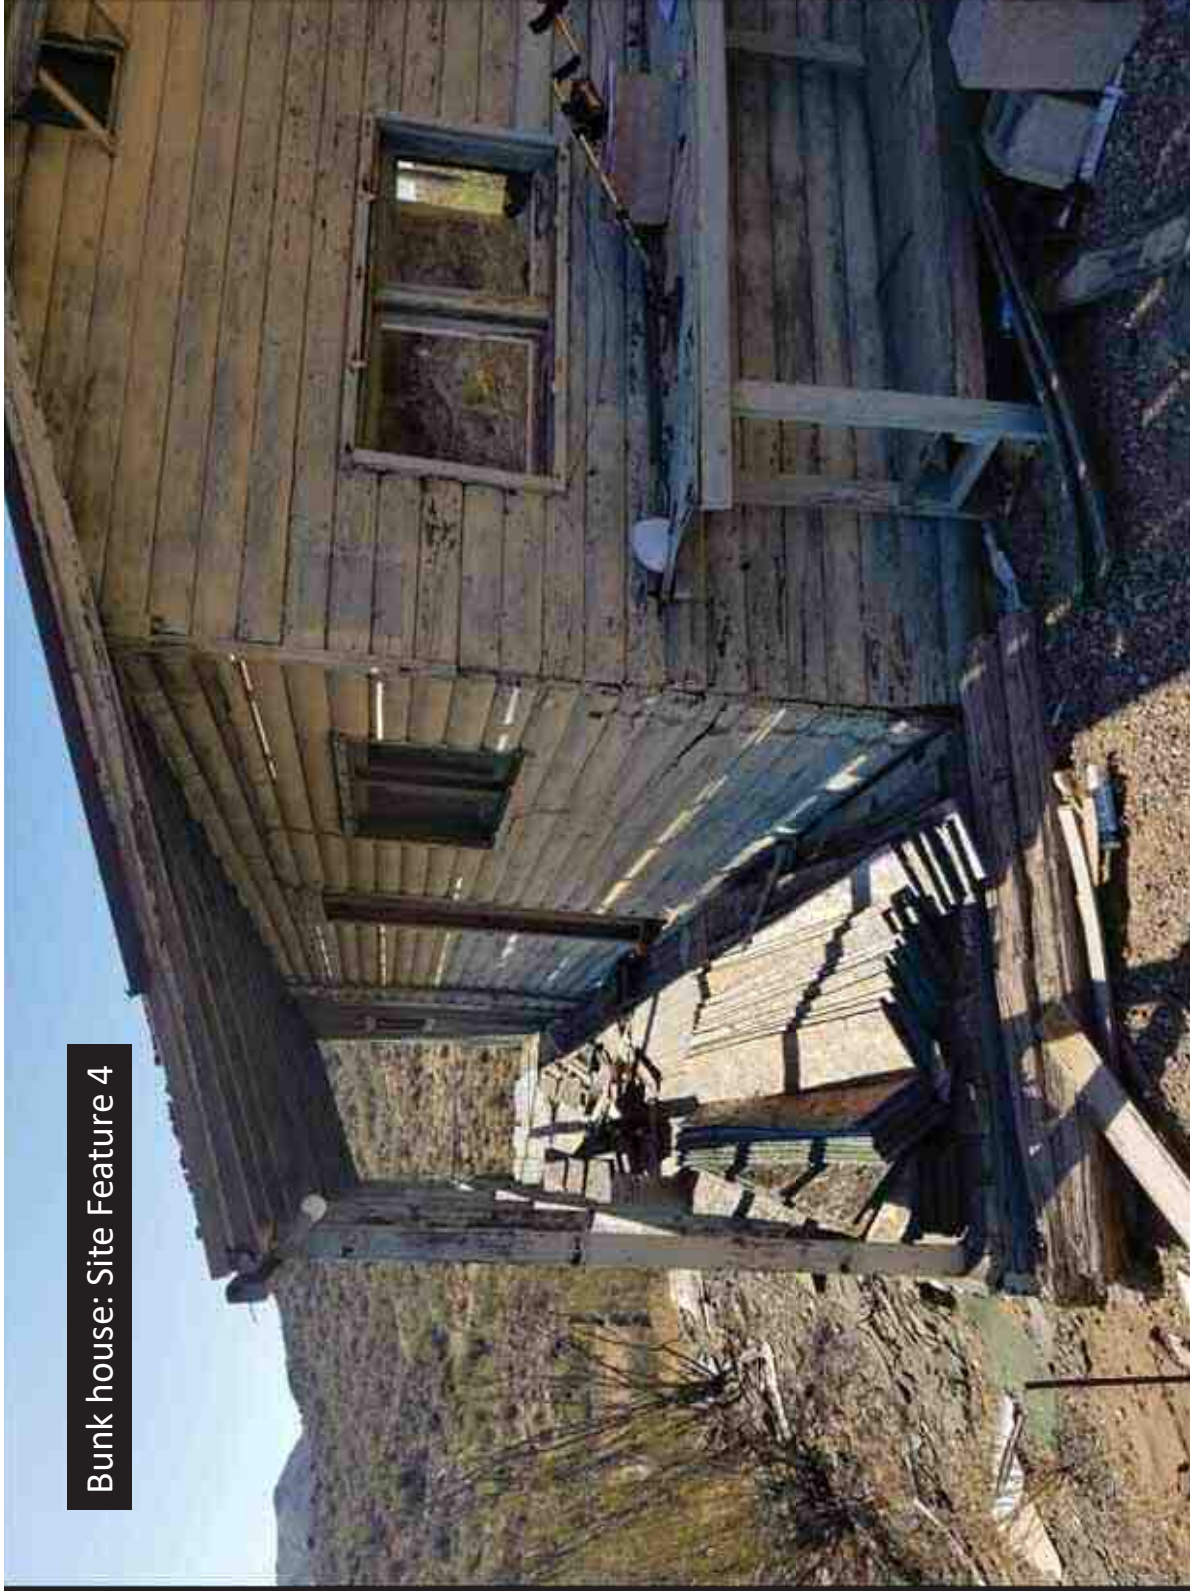
Bunk house: Site Feature 4

No MEC, MD or IEDs were identified at this location during the site visit. The bunk house appears to have been in the process of refurbishment and then the repair work abruptly stopped. Portions of the roofing shingles have been removed, a 5-gallon roofing tar container is on the roof, and siding material is stacked on the front porch. The interior of the bunk house is mostly free of debris. Roof shingles are strewn on the ground around the structure along with building materials.

- Recommendations
 - The shingles should be sampled for asbestos prior to their handling.

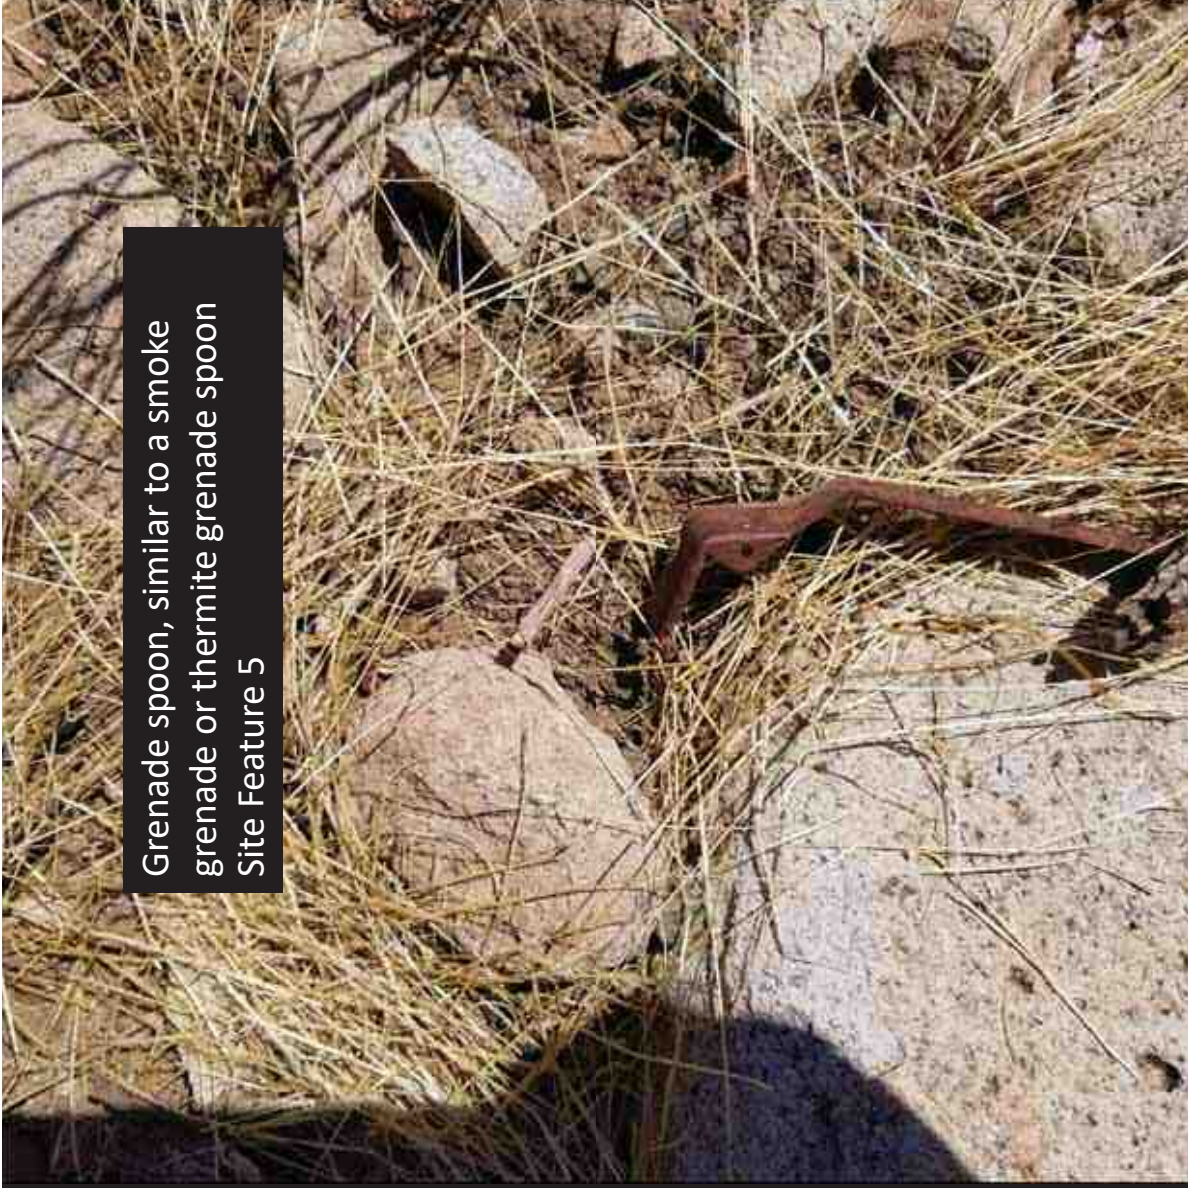
Grenade spoon, similar to a smoke
grenade or thermite grenade spoon
Site Feature 5

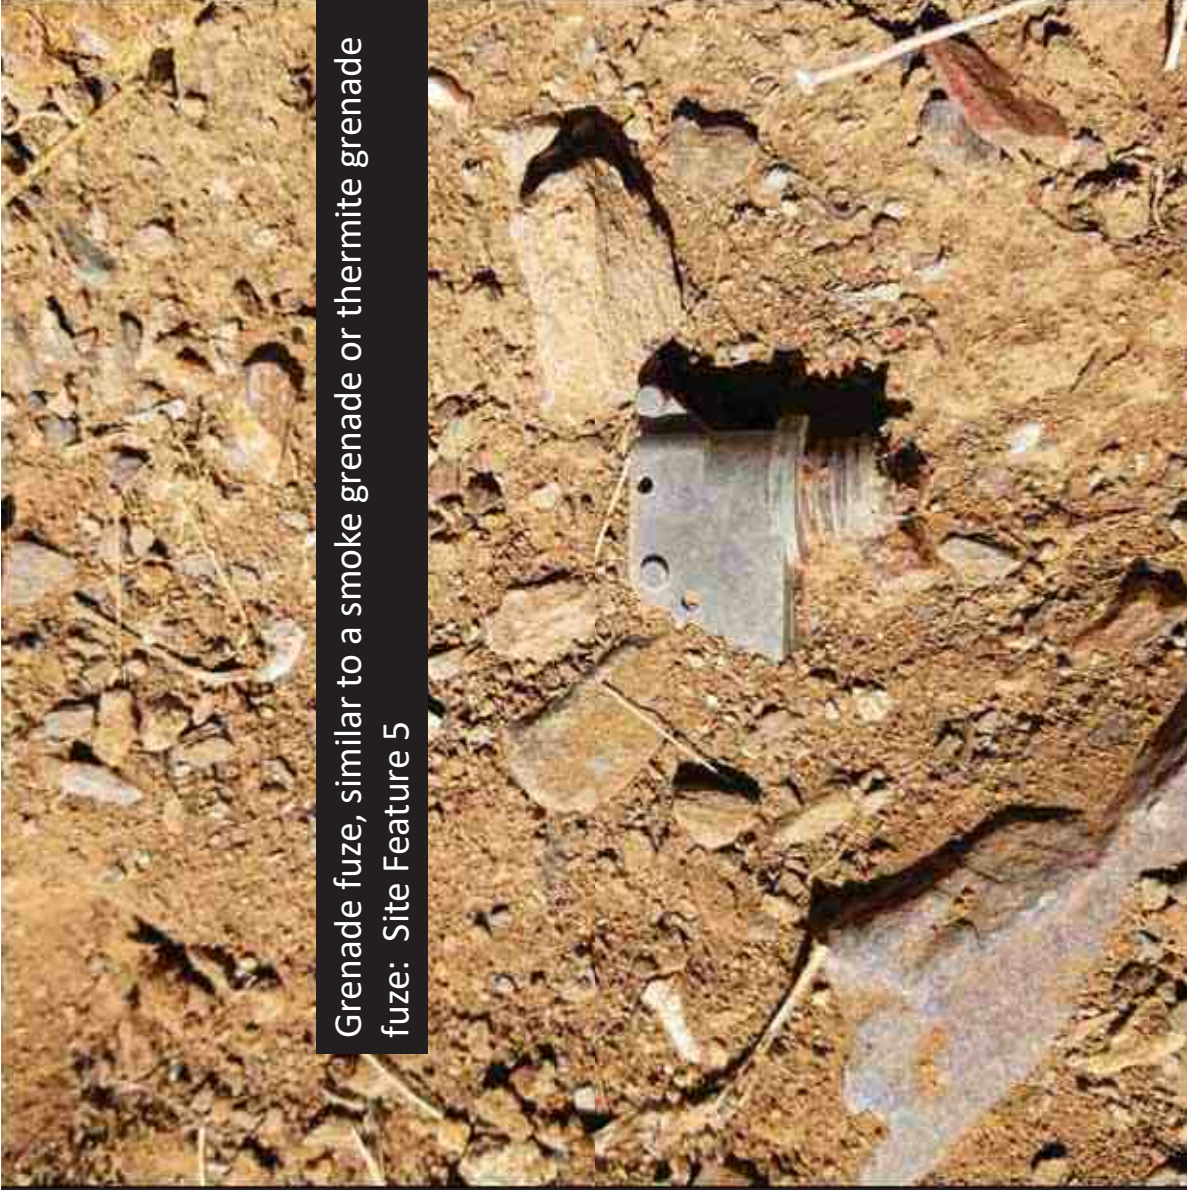
Grenade fuze, similar to a smoke grenade or thermite grenade
fuze: Site Feature 5

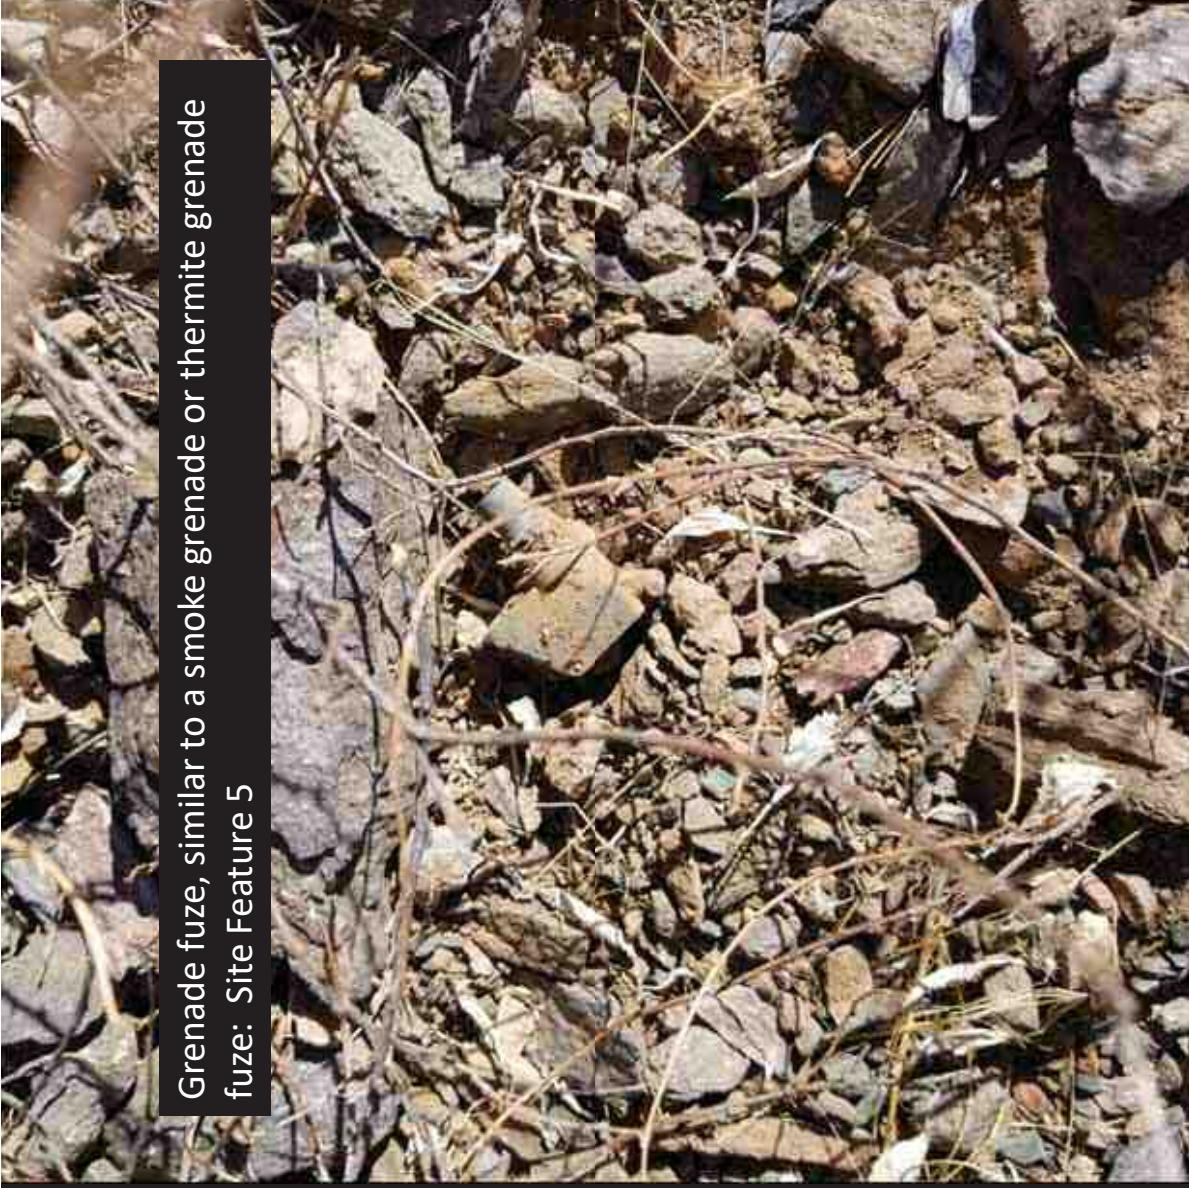
Grenade fuze, similar to a smoke grenade or thermite grenade
fuze: Site Feature 5

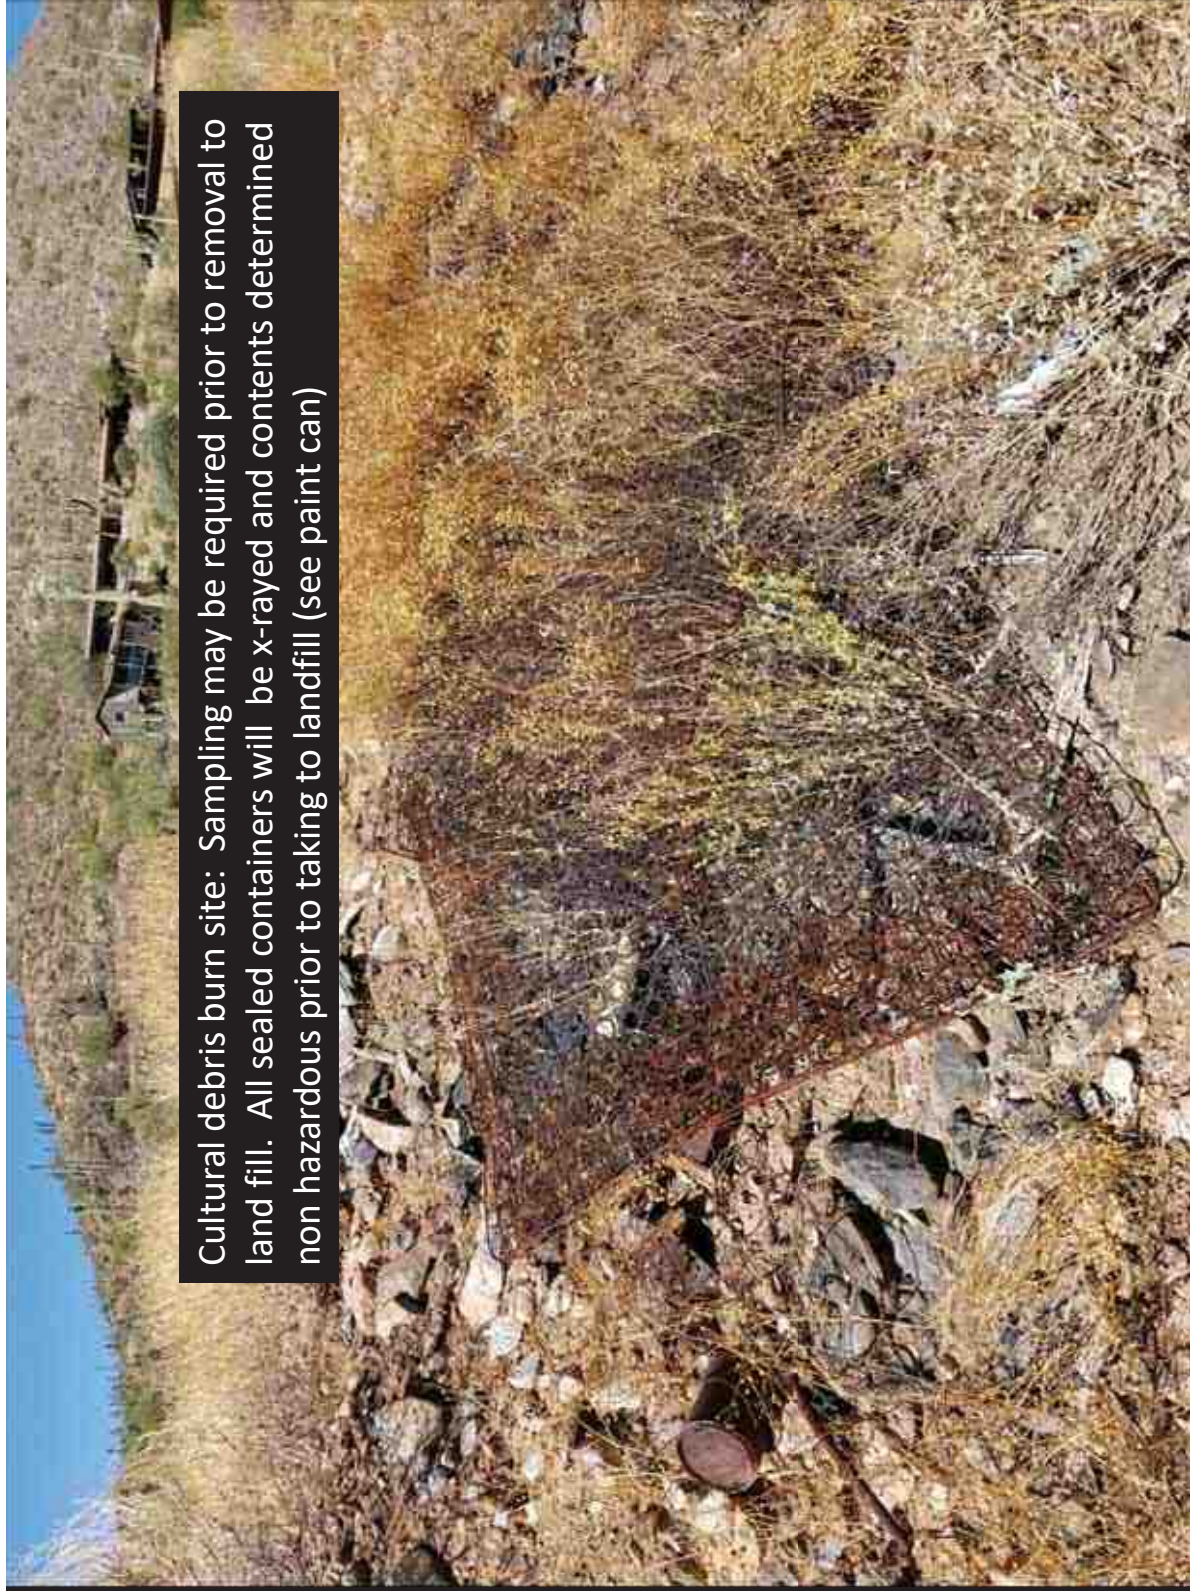
Directly to the south of the corral is a dump site. The inspection of the dump site revealed the presence of cultural debris including sealed paint cans. Two burn areas are present within this dump site.

Cultural debris burn site: Sampling may be required prior to removal to land fill. All sealed containers will be x-rayed and contents determined non hazardous prior to taking to landfill (see paint can)

- Recommendations
 - The cultural debris should be removed from the surface of the site prior to geophysical investigations of the dump site. Work production rates will benefit from a surface clearance of the cultural debris prior to subsurface investigations. This process will also provide an additional step for Quality Control (QC) (surface clearance QC and subsurface clearance QC).

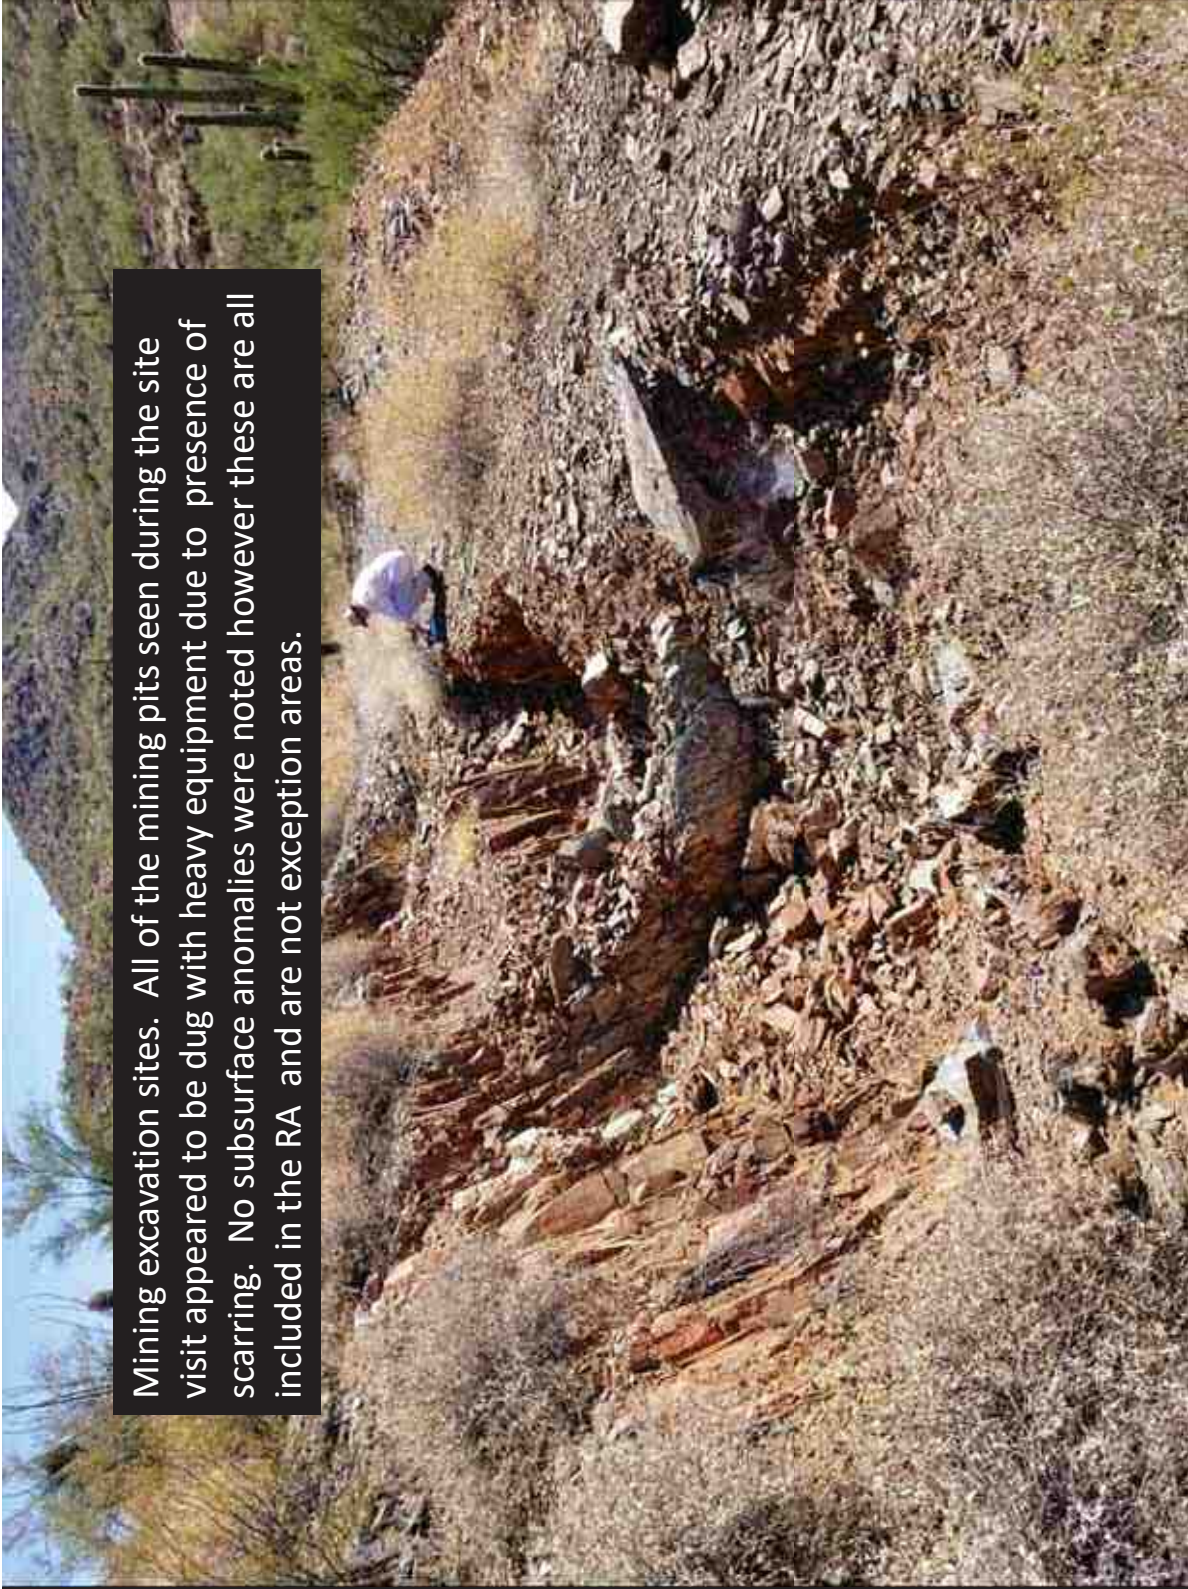
Mining excavation sites. All of the mining pits seen during the site visit appeared to be dug with heavy equipment due to presence of scarring. No subsurface anomalies were noted however these are all included in the RA and are not exception areas.

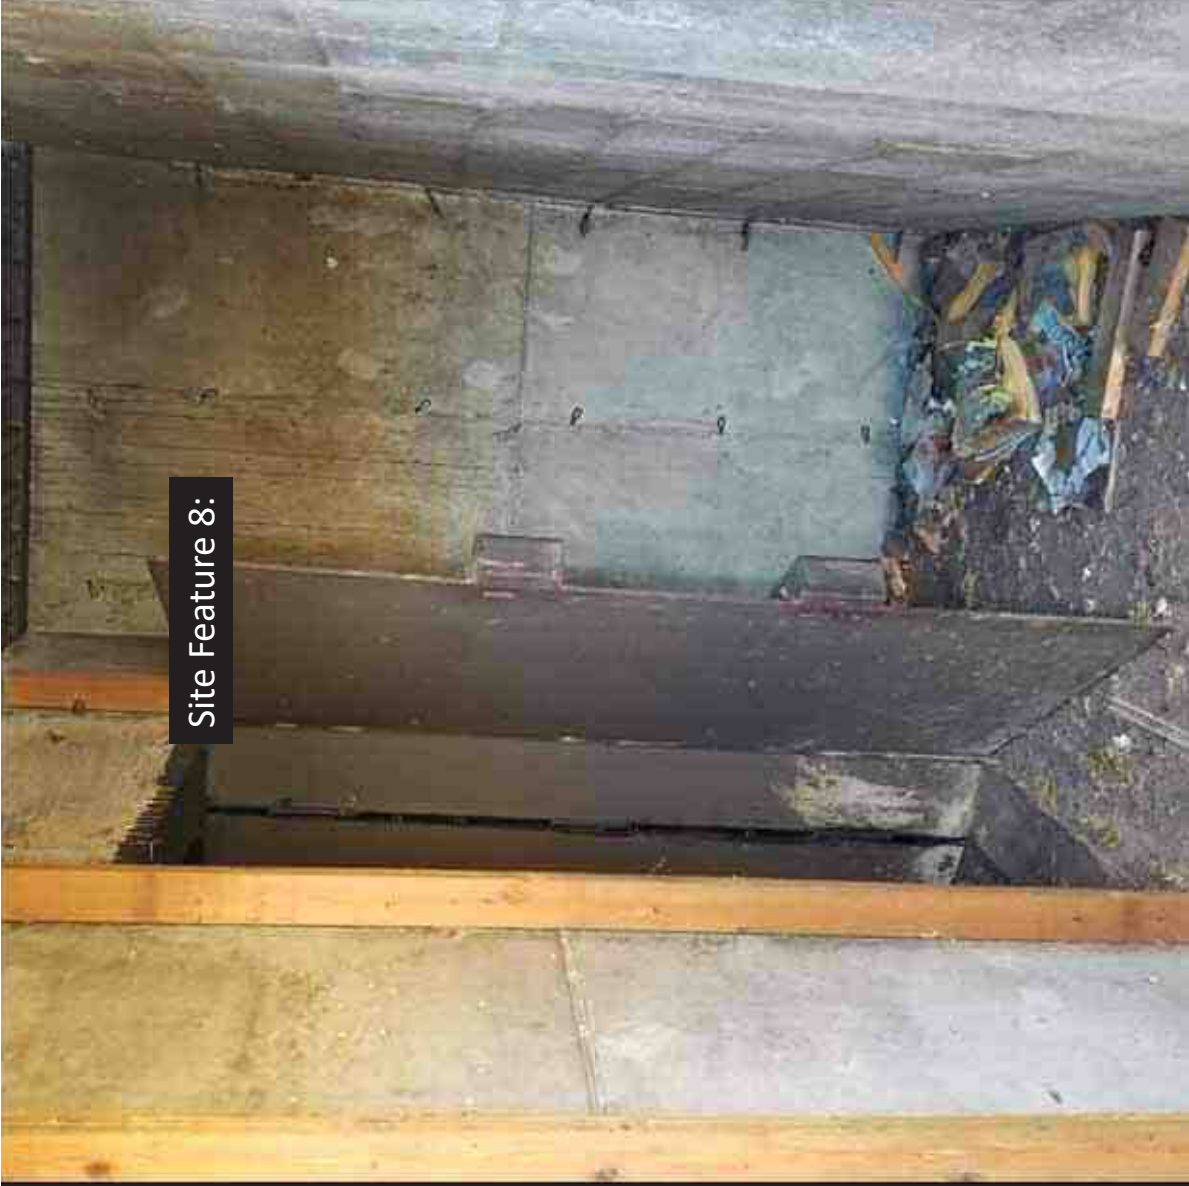
Site Feature 8:

door appears to have been forced open and the locking mechanism is no longer functional. The door was ajar when the Site Visit Team arrived on site. The interior of the magazine has debris present and there is evidence that a burn was conducted inside the magazine. The magazine walls are intact and the fire did not produce enough heat to cause spalling of the concrete. Evidence of snakes and rodents was present within the magazine. A false ceiling was observed in the magazine. The false ceiling is made of plywood and is in disrepair. The purpose of this false ceiling is uncertain as it wouldn't be needed in an explosive magazine.

- Recommendations
 - The burn area should be sampled for explosives to determine if any potential explosive hazards is present within the magazine.
 - The false ceiling along with the debris in the magazine is recommended for removal to ensure any potential explosive hazards are identified and properly disposed of.

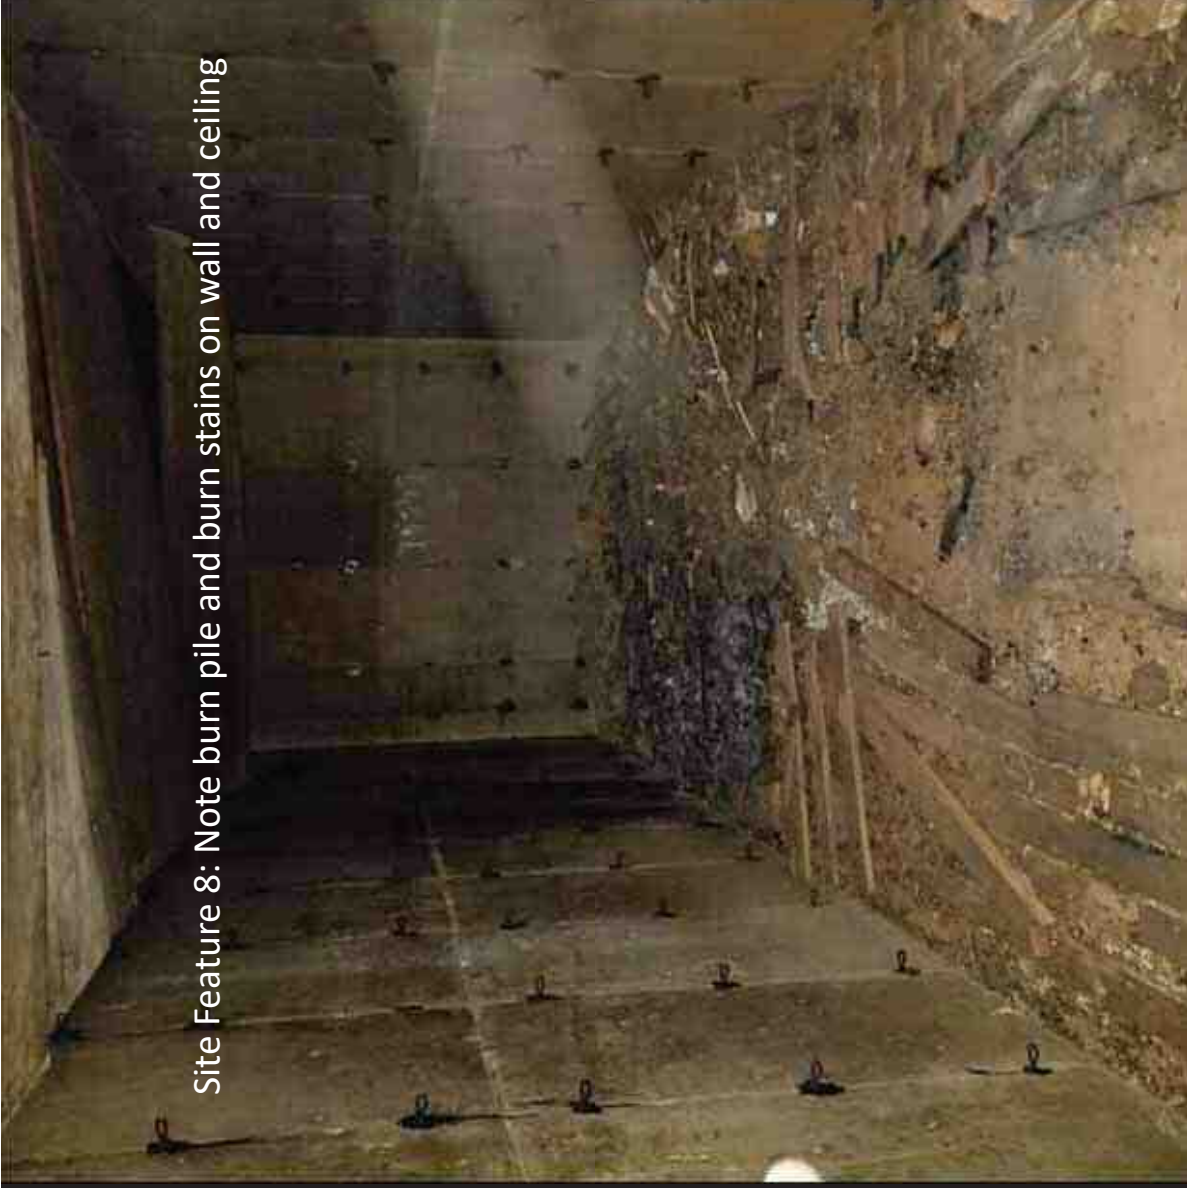
Site Feature 8: Note burn pile and burn stains on wall and ceiling
